## EXECUTIVE SUMMARY

# OBSERVATIONS & RECOMMENDATIONS

## French Pond, Henniker

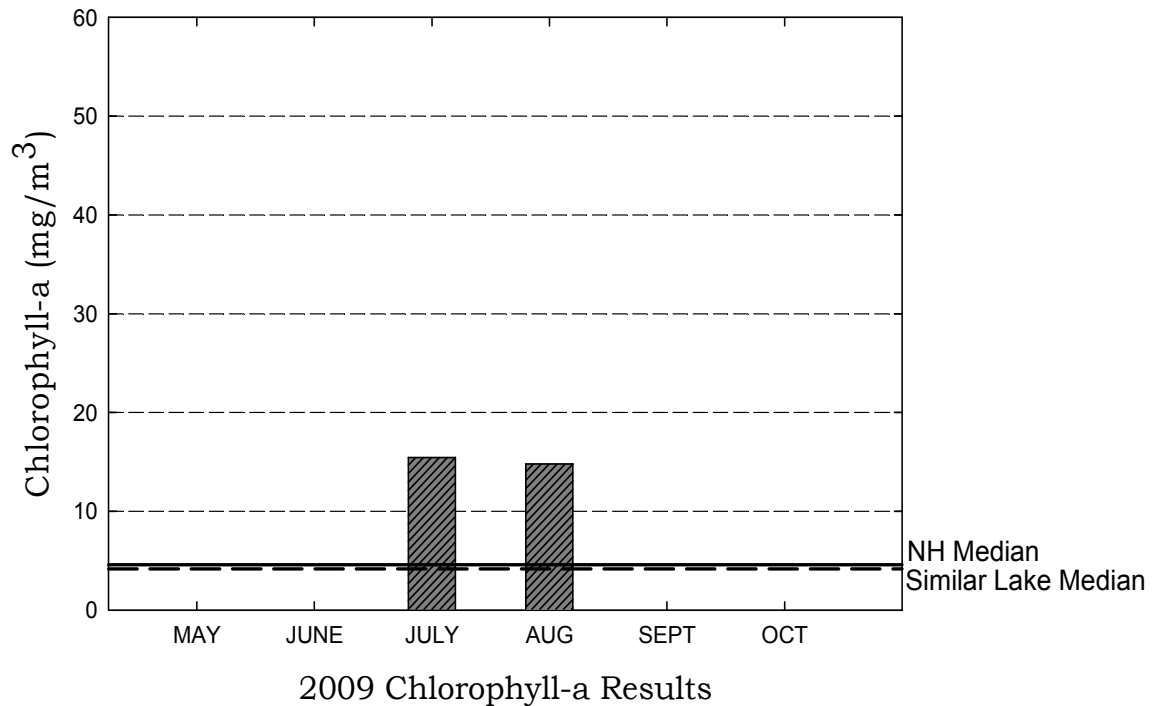
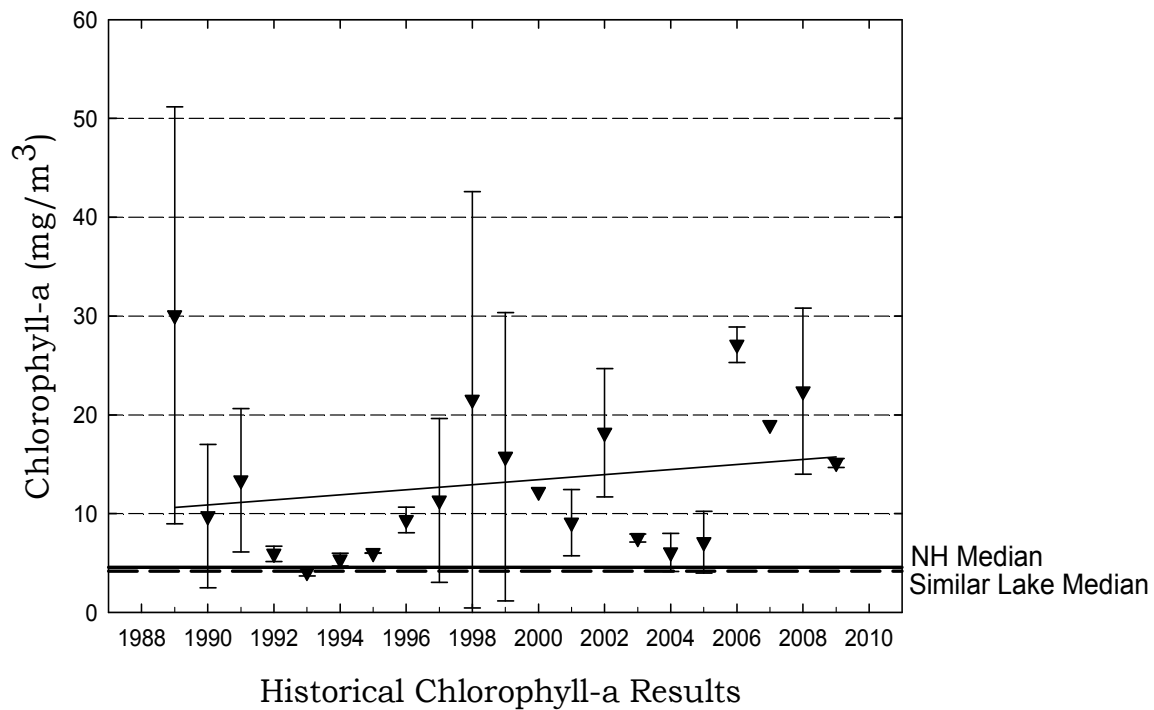
**Figure 1.** Monthly and Historical Chlorophyll-a Results

Figure 1 depicts the historical and current year chlorophyll-a concentration in the water column.

The current year data (the top graph) show that the chlorophyll-a concentration **decreased slightly** from **July** to **August**. Chlorophyll concentrations were **15.45 mg/m<sup>3</sup>** in **July** and **14.80 mg/m<sup>3</sup>** in **August** indicating an algal bloom, and more specifically a cyanobacteria bloom, had occurred in the pond.

The historical data (the bottom graph) show that the **2009** chlorophyll-a mean is ***much greater than*** the state and similar lake medians. For more information on the similar lake median, refer to Appendix D.

Overall, visual inspection of the historical data trend line (the bottom graph) shows a ***variable*** in-lake chlorophyll-a trend since monitoring began. Specifically the mean chlorophyll concentration has ***fluctuated between approximately 4.09 and 30.08 mg/m<sup>3</sup>*** since **1989**.

While algae are naturally present in all waterbodies, an excessive or increasing amount of any type is not welcomed. Phosphorus is the nutrient that algae typically depend upon for growth in New Hampshire lakes and ponds. Algal concentrations increase as nonpoint sources of phosphorus from the watershed increase, or as in-lake phosphorus sources increase. Increased Chlorophyll-a concentrations can also affect water clarity, causing Secchi-disk transparency to decrease (worsen) and turbidity to increase (worsen). Therefore, it is extremely important for volunteer monitors to continually educate all watershed residents about management practices that can be implemented to minimize phosphorus loading to surface waters.

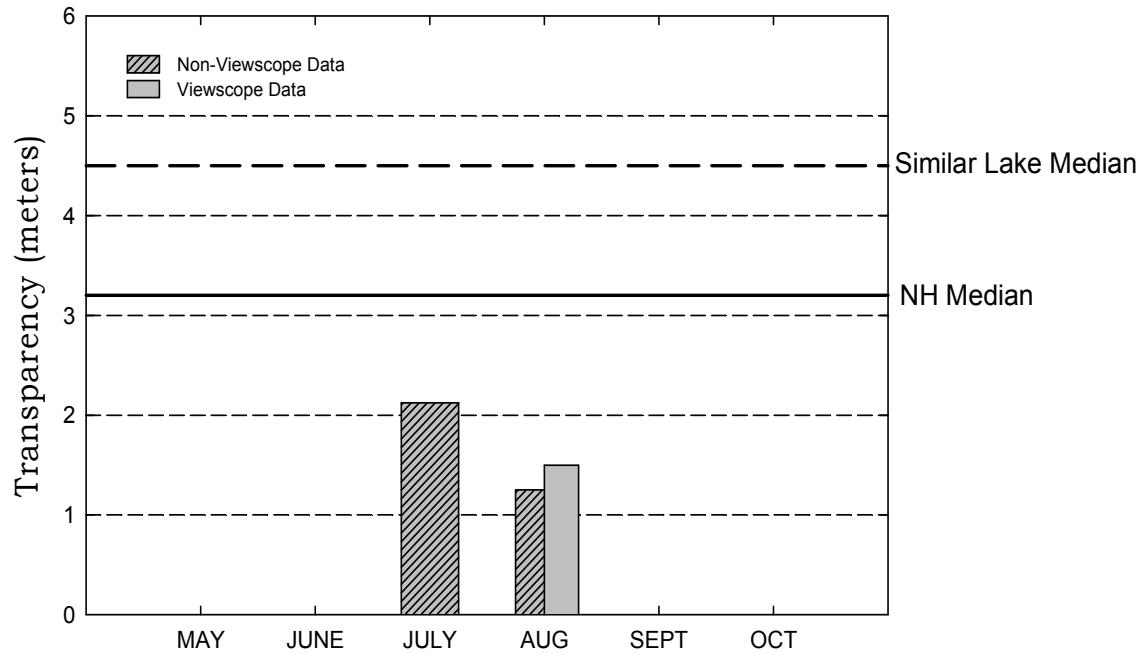
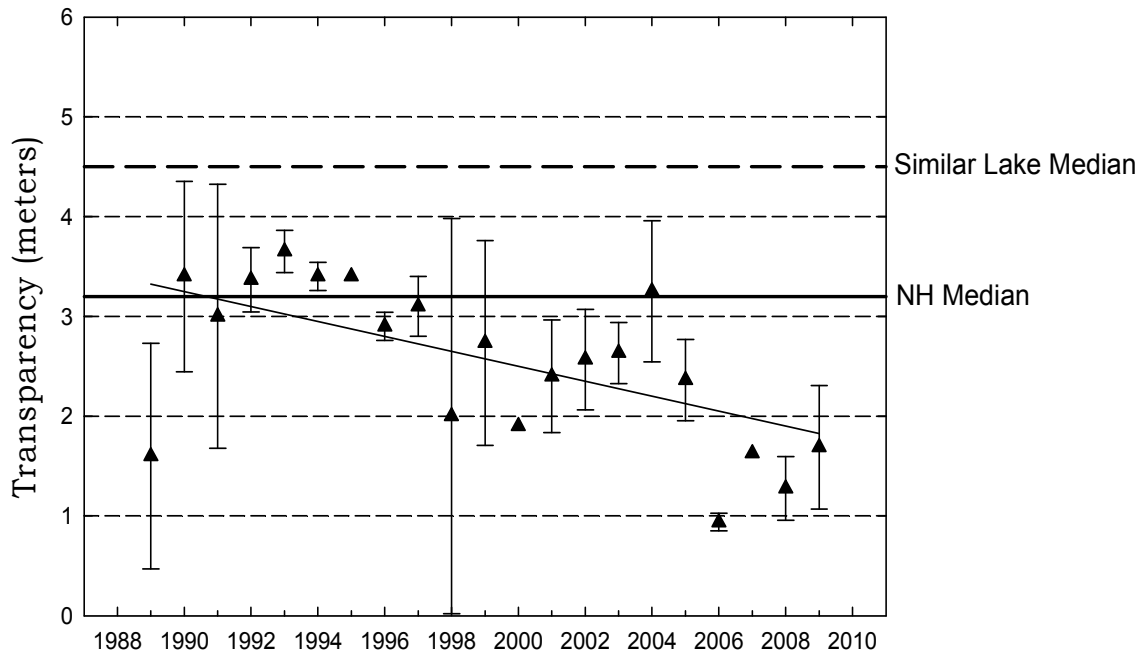
**Figure 2.** Monthly and Historical Transparency Results

Figure 2 depicts the historical and current year transparency *with and without* the use of a viewscope.

The current year **non-viewscope** in-lake transparency **decreased** from **July** to **August**.

The viewscope in-lake transparency was **slightly greater than** the non-viewscope transparency on the **August** sampling event. The transparency was **not** measured with the viewscope on the **July** sampling event. A comparison of transparency readings taken with and without the use of a viewscope shows that the viewscope typically increases the depth to which the Secchi disk can be seen into the lake, particularly on sunny and windy days. We recommend that your group measure Secchi disk transparency with and without the viewscope on each sampling event.

The historical data (the bottom graph) show that the **2009** mean non-viewscope transparency is **less than** the state median and is **much less than** the similar lake median. Please refer to Appendix D for more information about the similar lake median.

Visual inspection of the historical data trend line (the bottom graph) shows a **decreasing** trend, meaning that the transparency has **worsened** since monitoring began in **1989**.

Typically, high intensity rainfall causes sediment-laden stormwater runoff to flow into surface waters, thus increasing turbidity and decreasing clarity. Efforts should continually be made to stabilize stream banks, pond shorelines, disturbed soils within the watershed, and especially dirt roads located immediately adjacent to the edge of tributaries and the pond. Guides to best

management practices that can be implemented to reduce, and possibly even eliminate, nonpoint source pollutants, are available from DES upon request.

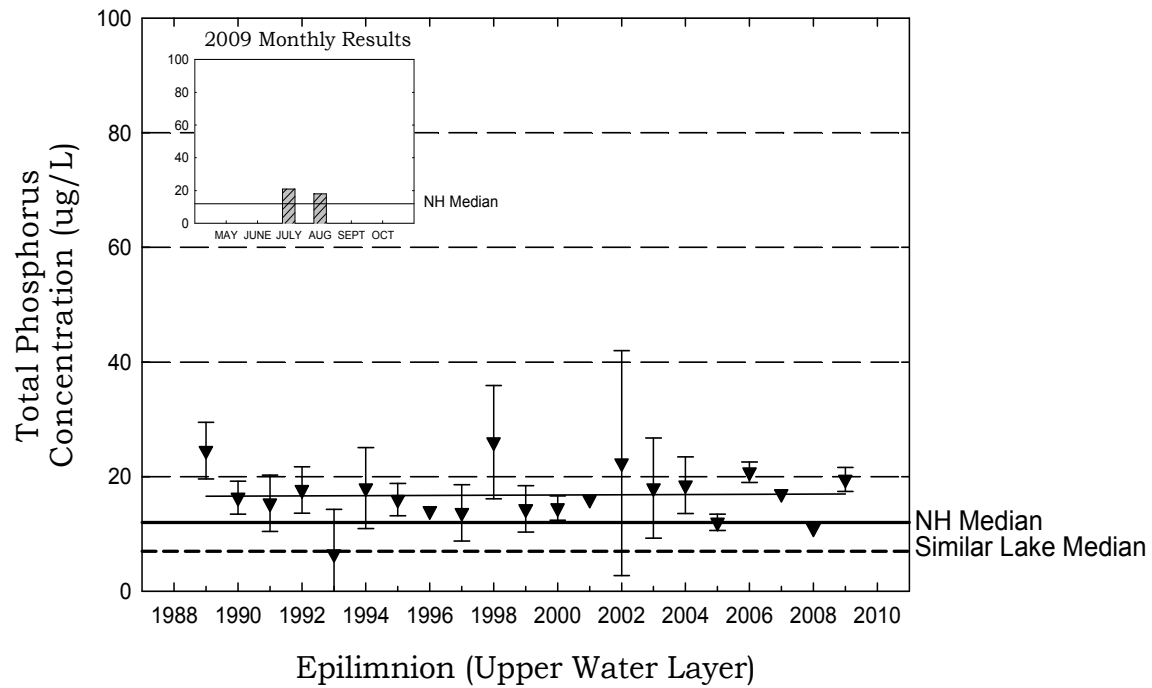
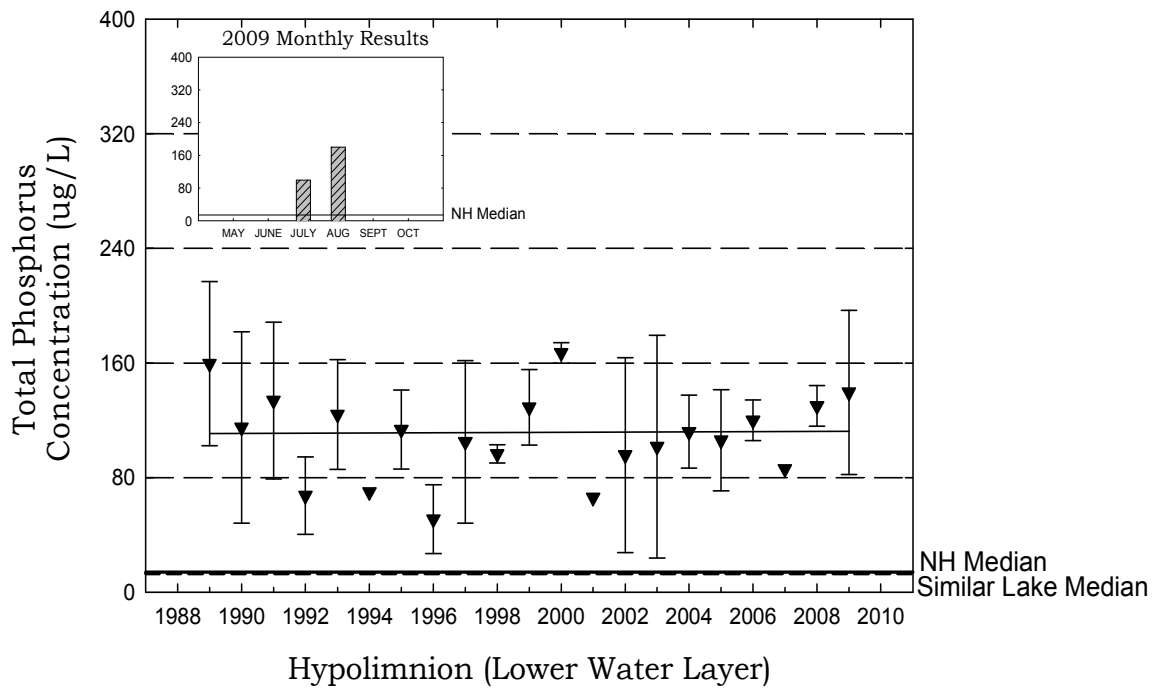
**Figure 3.** Monthly and Historical Total Phosphorus Data

The graphs in Figure 3 depict the historical amount of epilimnetic (upper layer) and hypolimnetic (lower layer) total phosphorus concentrations; the inset graphs depict current year total phosphorus data.

The current year data for the epilimnion (the top inset graph) show that the phosphorus concentration ***decreased slightly*** from **July** to **August**.

The historical data show that the **2009** mean epilimnetic phosphorus concentration is ***greater than*** the state and similar lake medians. Refer to Appendix D for more information about the similar lake median.

The current year data for the hypolimnion (the bottom inset graph) show that the phosphorus concentration ***increased greatly*** from **July** to **August**.

The historical data show that the **2009** mean hypolimnetic phosphorus concentration is ***much greater than*** the state and similar lake medians. Please refer to Appendix D for more information about the similar lake median.

Overall, visual inspection of the epilimnetic and hypolimnetic historical data trend lines shows a ***variable*** phosphorus trend since monitoring began. Specifically the mean annual epilimnetic phosphorus concentration has ***fluctuated between approximately 6 and 26 ug/L***, and the mean annual hypolimnetic phosphorus concentration has ***fluctuated between approximately 51 and 167 ug/L***, since monitoring began in **1989**.

One of the most important approaches to reducing phosphorus loading to a waterbody is to continually educate watershed residents about the watershed sources of phosphorus and how excessive phosphorus loading can negatively

affect the ecology and the recreational, economical, and ecological value of lakes and ponds.
